Woodstock Report

McHenry County Courthouse | Woodstock, Illinois

April 2012

Introduction

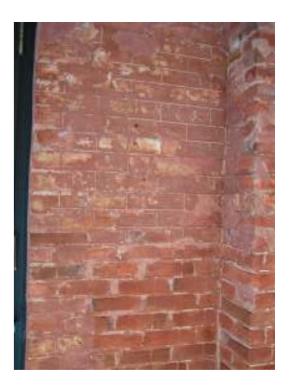
We would recommend that the critical areas that are open to the elements and are a source of water infiltration be repaired and restored immediately. Some encompass a sizable area. Sometimes the scope of work should be expanded to include other work in the same area. The cost of hydraulic lifts to reach an area may be more cost effective to do other adjacent incidental work at the same time.

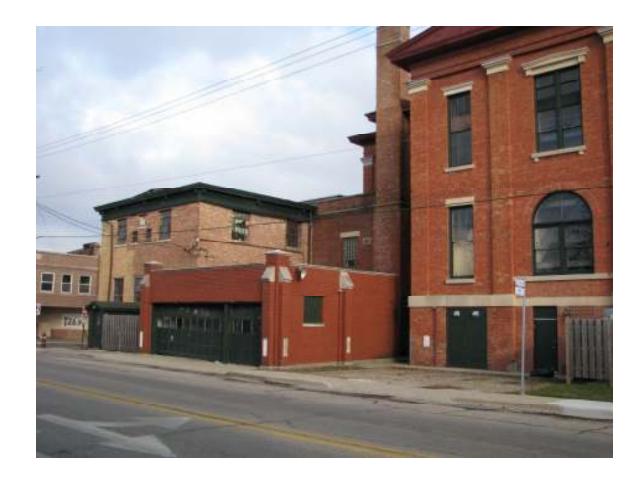
Garage

A building with no roof does not enhance the property's development potential. The garage should be removed. It serves no useful purpose anymore. The amount of repair would not be cost effective. The masonry materials and stone should be salvaged for repairs of later courthouse additions. Removal will not only provide easier access for repairs but opening up the area will enhance visually the whole west side.

Even planting grass would be an improvement instead of gravel and concrete. Long-term, planting of landscaping and trees would help improve the appearance around the entire courthouse perimeter.

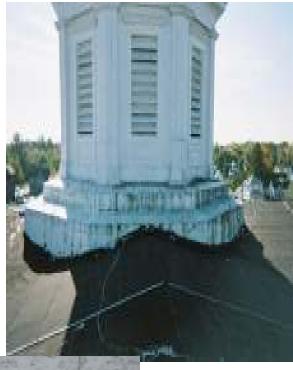
Courthouse Roof and Dome/Cupola

The original roof appears to have been a metal seamed roof. The current roof is a combination of rolled asphalt over the metal seamed roof with an adhered EPDM around the cupola. It should all be removed to the wood deck and a new standing seam metal roof or an EPDM membrane installed. The roof is barely visible from any direction.

Final roofing material selection should be thoroughly discussed regarding the pros and cons of each and the impact it may have on the use of Historic tax credits and minimizing long term maintenance.

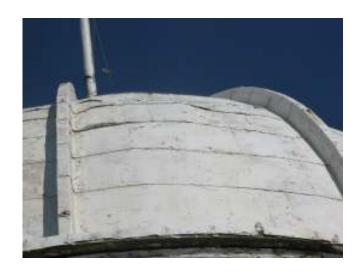
Dome / Cupola

The dome has a flat seam metal roof. We did not have an opportunity to inspect up close what the roofing material consists of. The exterior photos provide some insight as to its condition and the interior shots show the resulting water spots on the inside of the dome. Some of the roof deck will need to be replaced. The metal roofing should be replaced with copper or stainless steel terne for longevity and water tightness.

The wood trim and crown molding should be repaired and replaced in some areas. Replacement materials should be of mahogany or redwood to resist rot. Depending on the extensiveness of the damage other synthetic materials could also be utilized for replacement. In any case, creating a water tight system that can expand and contract with temperature changes is paramount to a long lasting solution. Restoring the cupola's details are crucial to the overall appearance and value of this building. An application of a multi-color paint scheme is extremely important in unifying the entire building.

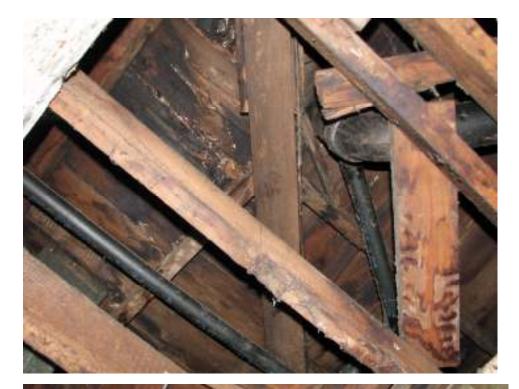
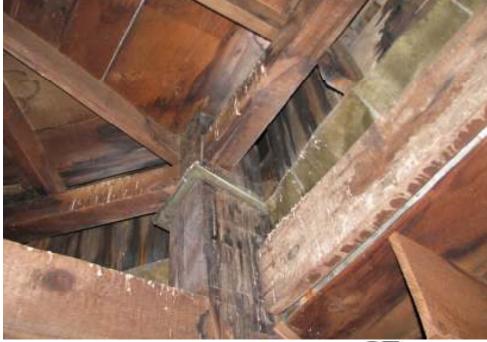
Dome / Cupola / Heavy Timber Structure

There are numerous places where water is infiltrating that will ultimately damage and destroy the heavy timber structural members. This has to be addressed immediately to keep the water out. All open joints and seams must be sealed up as a temporary measure. On the exterior (as a temporary measure) the open joints of the wainscoting should be covered and sealed with aluminum coil stock. Holes in crown molding should also be covered and sealed.

Pigeon droppings are scattered about the attic. Brushing and vacuuming of those areas would be desirable. There are companies that can safely remove the droppings at a reasonable cost.

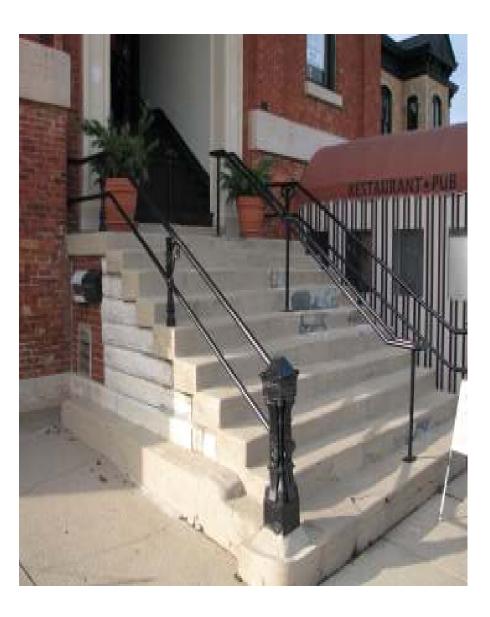
Courthouse Exterior

The front Courthouse stairs have been patched and coated numerous times. Currently they are a liability. They need to be totally stripped down to the original stone surface to see what condition they are in. The stair treads may be worn. However, they may be flipped over for a flatter, straighter surface or even be recut.

Options are available to do a long lasting, maintenance free restoration. It would also be an opportune time to restore the railing system to its original appearance. Fulfilling current code requirements for the railing can be done without destroying the original design intent.

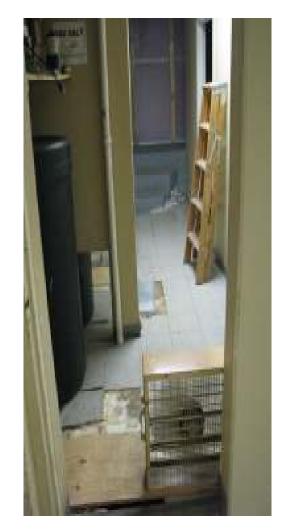
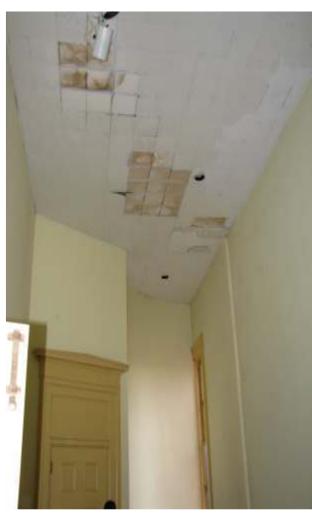
Courthouse

The critical needs for the interior are leaks in the water supply or waste lines at the 2nd floor of the courthouse. The leaks are in the walls and or in the ceiling and need to be found and repaired. The basement kitchen area in the courthouse has some mold on the drywall at the former boiler room area. It should all be removed

The built up floor in the old boiler room should be removed. Large amounts of moisture and the lack of ventilation in the crawl space has caused lots of problems and has accelerated the deterioration in the plywood deck. From our initial observation, this area could possibly be a location for a new elevator.

The water heater and softener need to be relocated due to the floor condition. If a tenant for the restaurant is found, the decision would need to be made quickly as to where to relocate the equipment.

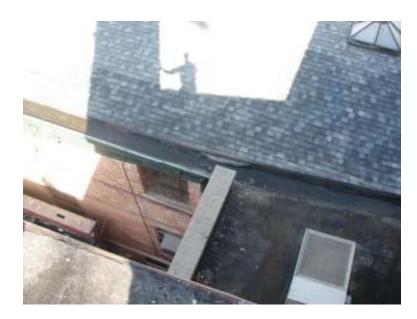
The Sheriff's House needs a general cleaning to show its potential for perspective tenants or developers . It appears that a secondary roof structure was added on top of the original roof at the rear jail section of the building to probably address some previous water problems. Given the condition of the interior ceiling and wall plaster, the moisture problem was over an extended period of time. Not knowing what the condition of the original roof deck was or is and the structure on top if it, it is difficult to access the cost of removal, repair or reconstruction of the roof deck or the structural elements that frame it. In any case, it should be thoroughly investigated.

The interior finishes of the jail section of the building is in a very deteriorated condition. The plaster ceilings are not code compliant nor are they acceptable for a food establishment. The ceilings of the jail cells are the only thing protecting the restaurant supplies from falling plaster.

If the La Petite café stays, the deteriorated plaster ceilings need to be removed. The wire mesh that holds the plaster has rusted away in so many areas. Total removal is the only option. The heat from the refrigeration compressors is also a problem. The current ventilation method is unacceptable. Adding mechanical exhaust with timing devices should be considered. How its done should be aesthetically pleasing and also respect the buildings character.

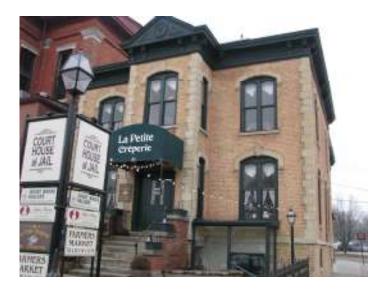
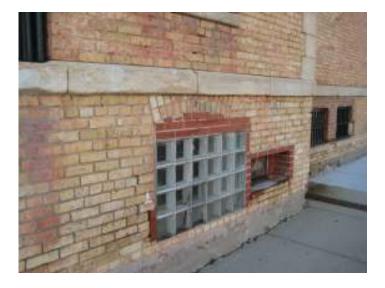
Sheriff's House Exterior

Inappropriate modernization disrespected the building's original window openings. Not matching the original brick downgrades the building's appearance and value. Windows merely become holes in the wall. The original openings should be restored. These are the kind of details, that over time, ruin the public's perception of a building.

If painting the exterior is not completed as part of the immediate critical needs, it should be included in the long term needs. Repainting with an appropriate multi color paint scheme will instantly change perceptions and attitudes about the court house and the café. It's about making good business decisions that can turn a business and building in a positive direction. It will show that the community cares and embraces one of its landmark buildings.

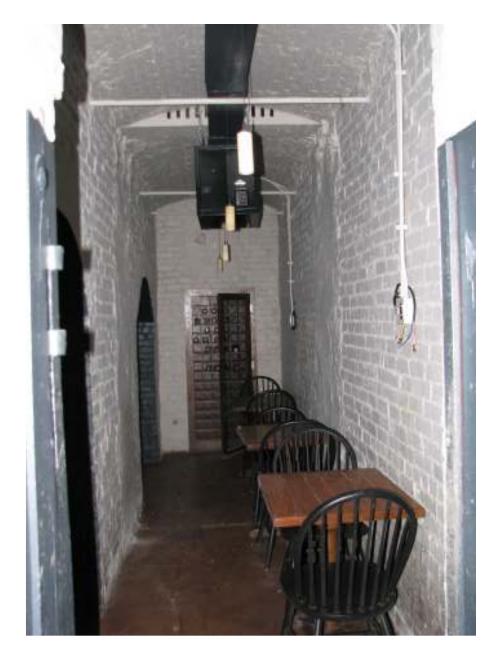
Courthouse

The lower level of the courthouse restaurant area has an exceptional character in its masonry walls in the original jail area. Unfortunately, the brick is painted and much of it's charm is lost. The paint should all be stripped to expose the original brick.

The rest of the lower level restaurant has lay-in acoustical ceilings in public dining areas that are totally out of place in this historic structure and should also be removed.

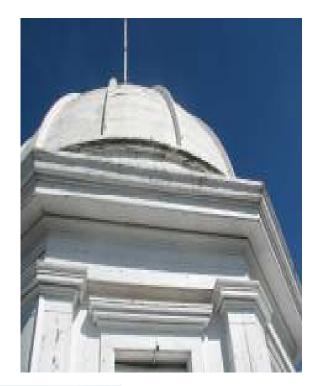
Dome / Cupola

Restoration of the dome as well as roof and gutter replacements are essential. In our introduction and in discussing critical needs, we spelled out the needs of preserving a key component of the building's identity. There are no short cuts if the structure is to have a long term future.

Restoring its architectural details and repainting its original colors are all essential. Removing and restoring the roof membrane and gutter system should all be part of a long term solution to keep the building watertight.

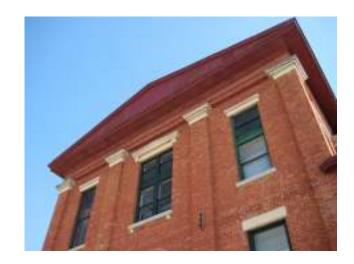
Windows and Masonry

Quite a few of the Courthouse windows have been altered over the years and should be restored to their original appearance. Many of the window muntins are gone in many of the windows sashes. Glass block should be removed and replaced with double hung window units. Some window sashes need to be replaced and others restored.

Masonry needs to be properly repaired in numerous areas. Previous repairs are of poor quality and contribute to the patched appearance. Better matching brick can be found and the mortar joints should and can be blended to match the adjacent surfaces.

Efflorescence should also be removed where moisture has been a problem. Repairs to the downspouts or total replacement should be considered. Heat tape should also be installed to minimize freezing that causes downspout joints to open up. The use of heat tape is a maintenance item. But it's a better alternative than allowing masonry to spall and fall.

Windows should also be painted with a multi color paint scheme that would compliment the masonry brick and stone.

We do not feel that tuck pointing the entire building is necessary or needed. Utilizing a skilled mason contractor knowledgeable in preserving historic masonry structures is essential.

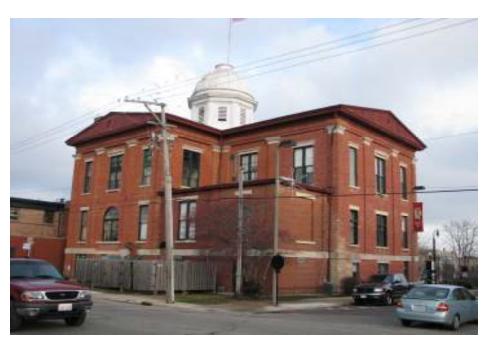
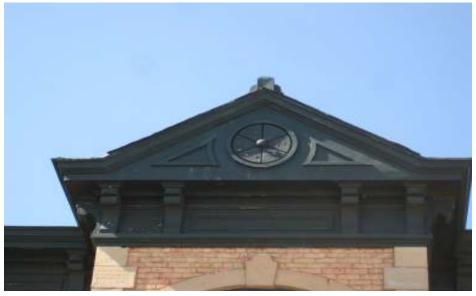
Exterior

The Courthouse's color scheme is disjointed and does not enhance or compliment its architectural features. The white Cupola Dome looks like it belongs on another building. A multi-color paint scheme needs to unify all of the building's assets and details.

The Sheriff's House is a prime example of how the lack of color and the dark paint scheme conceals all of the building's primary architectural details and assets. A multi-colored paint scheme would not only restore its original architectural integrity, but would have an immediate positive impact on the entire Square. It would also impact the current café business in a very positive way.

Bricked in window openings should be opened up and windows installed. The west elevation would also be improved if the overhead utility line were buried.

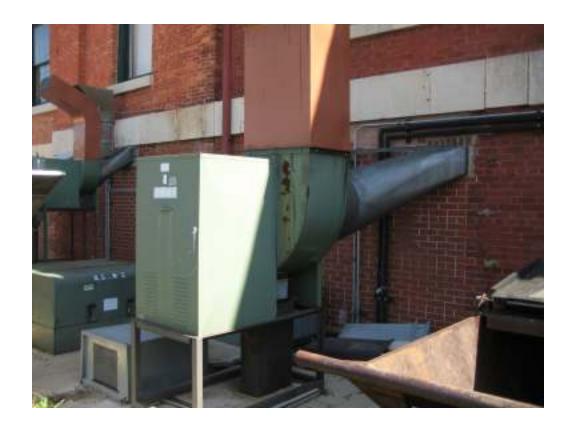
Exterior

The west side of the Courthouse is very uninviting and unsightly. The restaurant mechanical equipment is an eyesore and needs to be redone. The fence looks like a stockade.

The West side should be considered for another entrance to the Courthouse. The Courthouse will need an elevator to be accessible and have a future. Installing an elevator next to the west stairway appears to have the best opportunity to access most areas and not destroy architecturally significant interior spaces.

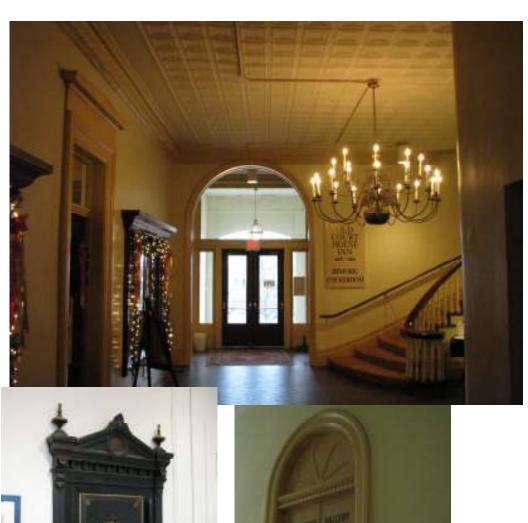
Courthouse Interior

The Courthouse interior has lost much of its original finishes and details. Painted woodwork and a monotone paint scheme have left it uninspiring and feeling like just another tired, old building. Restoring the original wood finishes and stenciling would enhance the buildings value and visitor attraction. The building has many visual assets and details that are hidden due to a very inappropriate color scheme.

Unfortunately, the courthouse interior walls inhibit flexibility for many potential users. However, some wall partitions could be removed. In seeking future tenants, the building's character and quality finishes will be its primary attraction.

Some of the ornate vault doors should be retained as part of the buildings history and character. The ornate vault doors are an asset and should be celebrated.

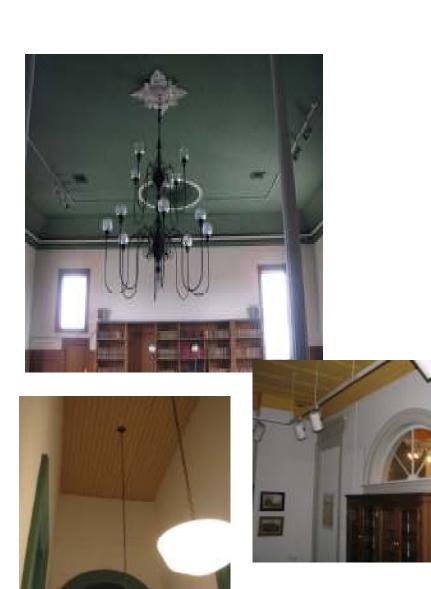
The second floor has extremely high ceilings. The courtroom ceilings add a special dimension to the space. However, in the rooms to the south, the ceiling height is excessive for most users. Some options could be explored to utilize the volume of space better.

Finishes are lackluster and could be enhanced significantly by returning to the original wood finishes. The modern wood paneling should be removed, and may reveal the original wood wainscoting. The original wall finishes should be investigated prior to finalizing finishes. Stripping the paint on the walls should reveal a lot more architectural details.

A third floor could easily be added for additional floor space if the costs could be justified relative to the income projections. Flexibility of the room's configurations is also key to potential users.
